## Surface Insulation Resistance (SIR) Analysis of IPC-B-52 Boards

Purchase Order #: 11111  
PAL Report Number: 2000-003

**Custom Solutions Inc**  
111 S. Client Blvd.  
Someplace, IN 46900

Date: March 02, 2010

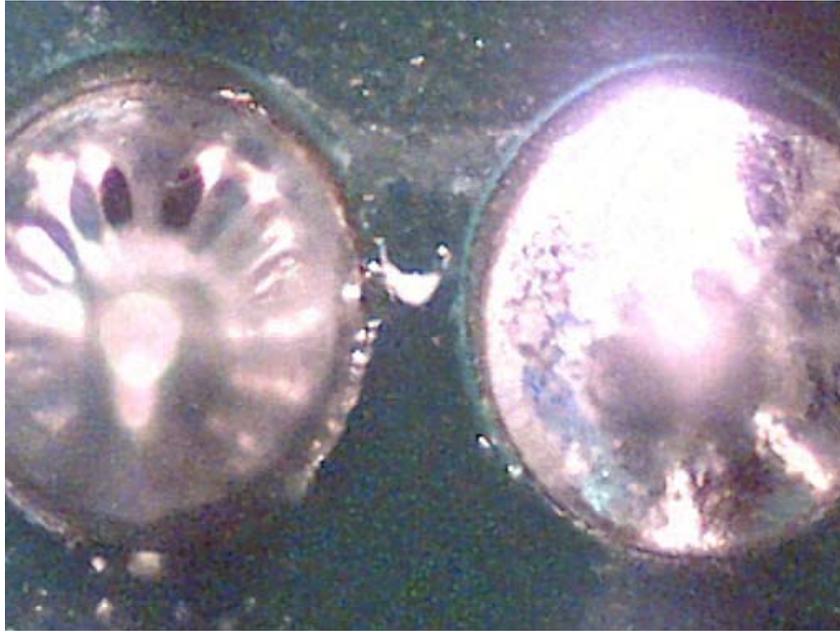
The results from the visual inspection of the boards can be found in the accompanying Excel file (labeled 2000-003 SIR Data). The visual inspection of the processed cards revealed a number of different items. First, with respect to the J1 and J2 connector sites, heavy concentrations of white and/or brown flux residues were noted on the bottom side of those locations. A few boards had pockets of brown residue on the bottom side of the J1 and J2 sites, which might have been from touch-up operations. Similarly, heavy concentrations of flux residue were noted in the 0805B sites of all boards. Also noted was the adhesive used to attach the chip capacitors to the board prior to reflow.

In terms of the J1 and J2 connector sites, the SIR levels were overall very poor for the processed boards. Additionally, both of these sites were low on the control boards as well. Given that the control board showed poor SIR levels in those areas, it is difficult to assess to what extent the low SIR levels are due to the flux or to the starting board cleanliness.

Pattern J1 (flux residue) – Board 1

We would recommend working with the board supplier to improve the cleanliness of the boards being shipped to you. We would also recommend re-evaluating this set of materials. However, we would verify the board cleanliness by ion chromatography before spending the time processing the boards.

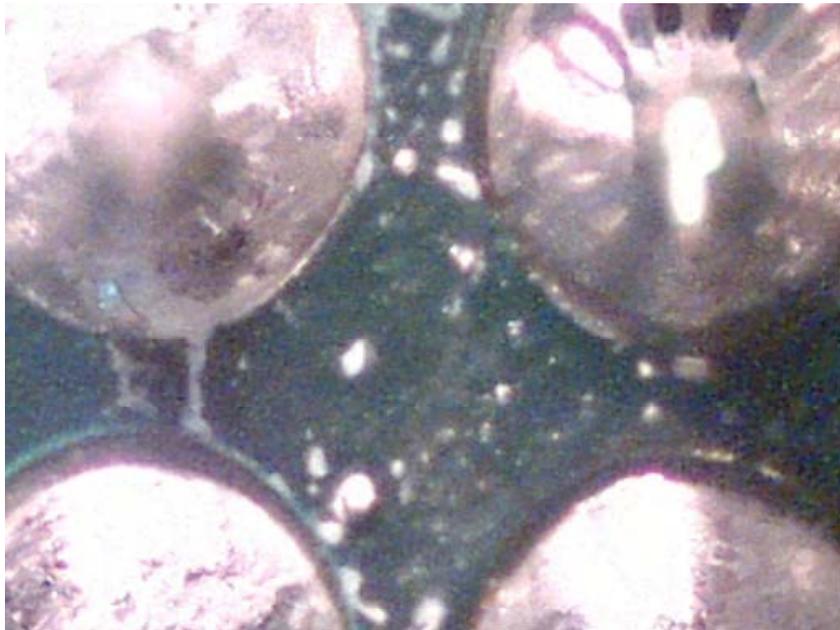
Pattern J1 (flux residue) – Board 1

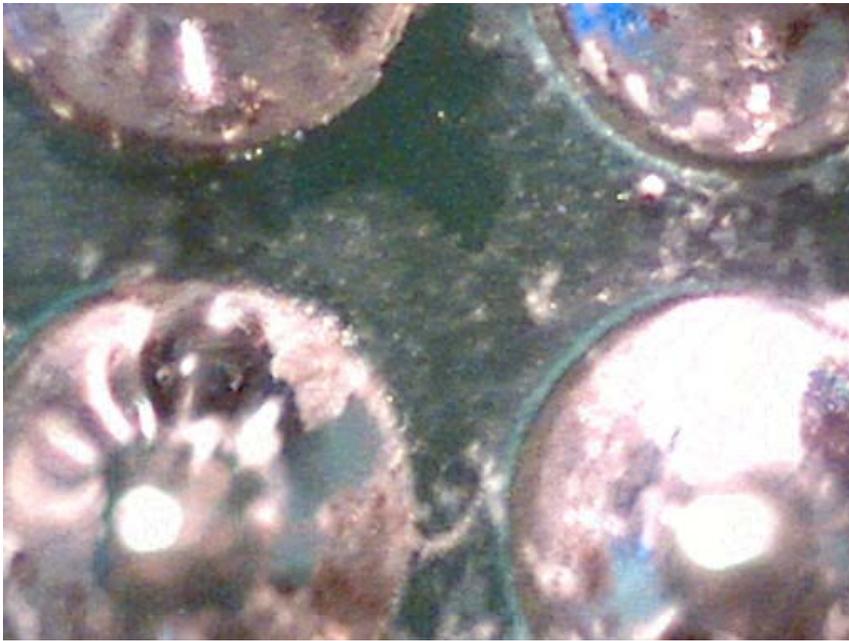
Pattern J2 (flux residue) – Board 1

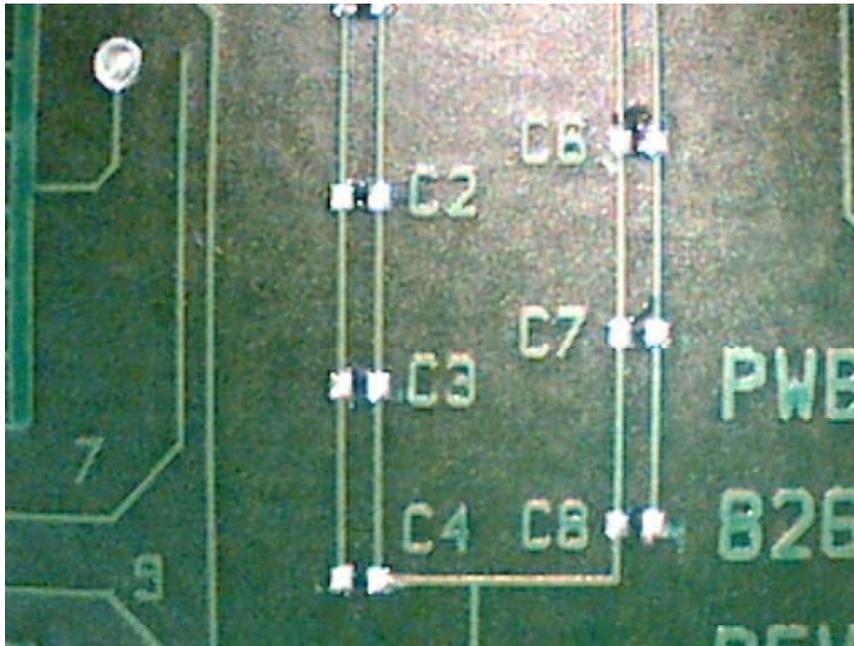
Pattern 0402 (flux residue) – Board 1

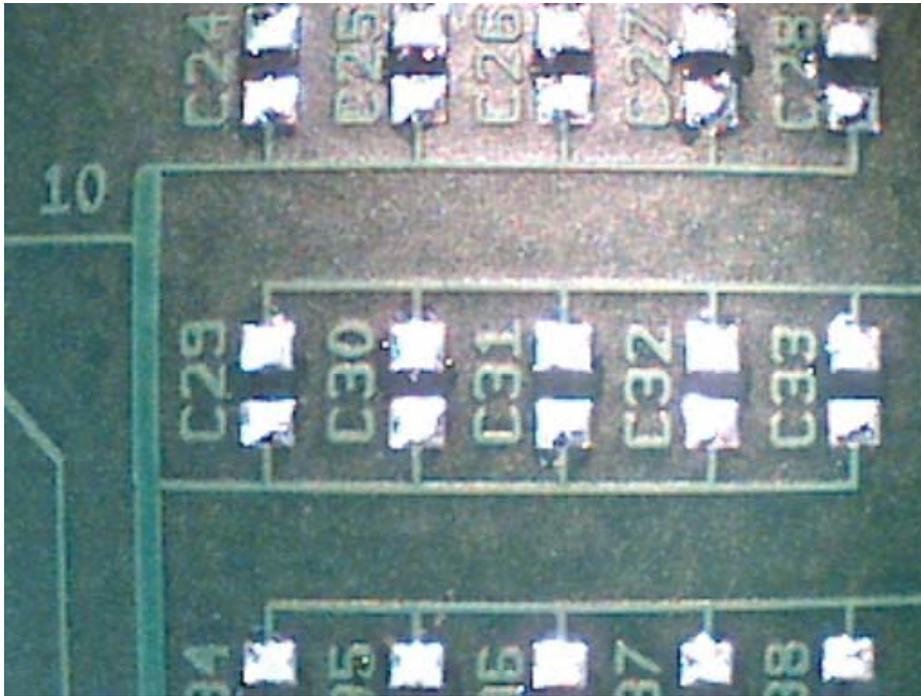
Pattern 0805T (flux residue) – Board 1

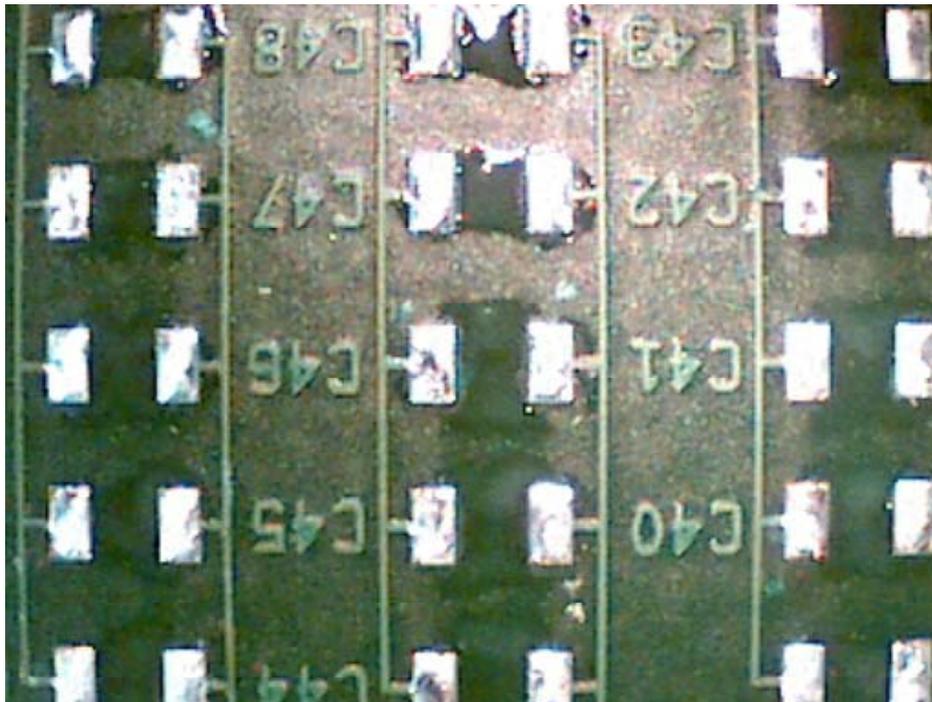
Pattern 1206 (flux residue) – Board 1

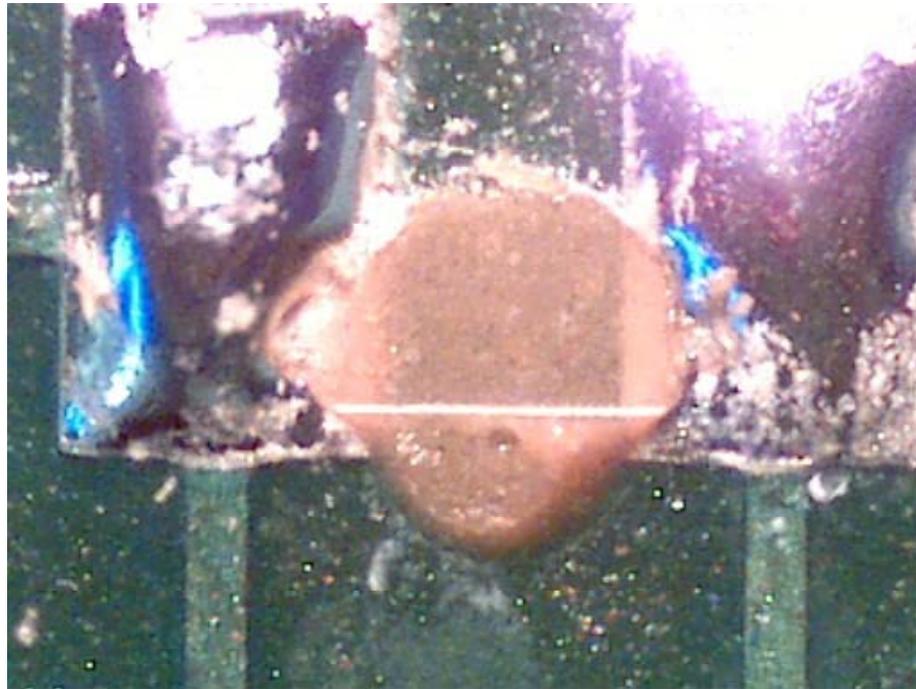
The 0805B location, on the bottom side of the board, was below the limit for all boards for the duration of the test. However, the control showed good SIR levels for this location.

The bottom side 0805B location was processed with not only the solder paste, but also a surface mount adhesive and was exposed to the wave solder flux. The SIR levels for all of the 0805B locations were poor. Again, since the topside surface mount parts were processed with the same solder paste, we don't believe that the solder paste by itself is a problem. The low SIR levels noted for this location may be the result of incompatibilities between the solder paste flux, wave flux and adhesive.

Pattern 0805B (flux residue and SMT adhesive) – Board 1

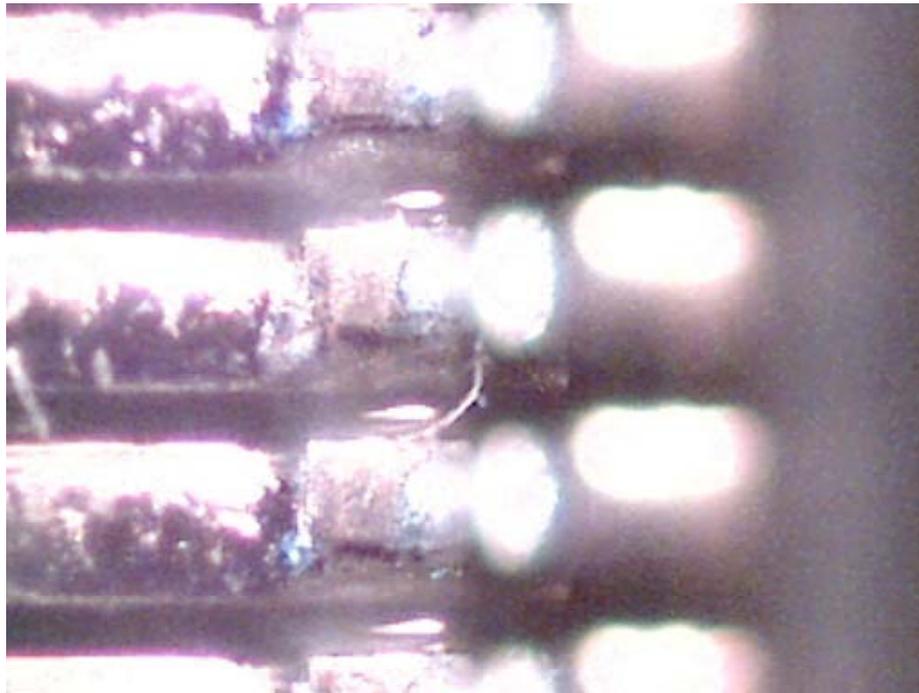
In addition to the flux residues, we noted several locations with fibers. Fibers can be problematic in that they may absorb sufficient moisture to allow leakage between two opposing conductors.

Pattern QFP160 (fiber) – Board 1

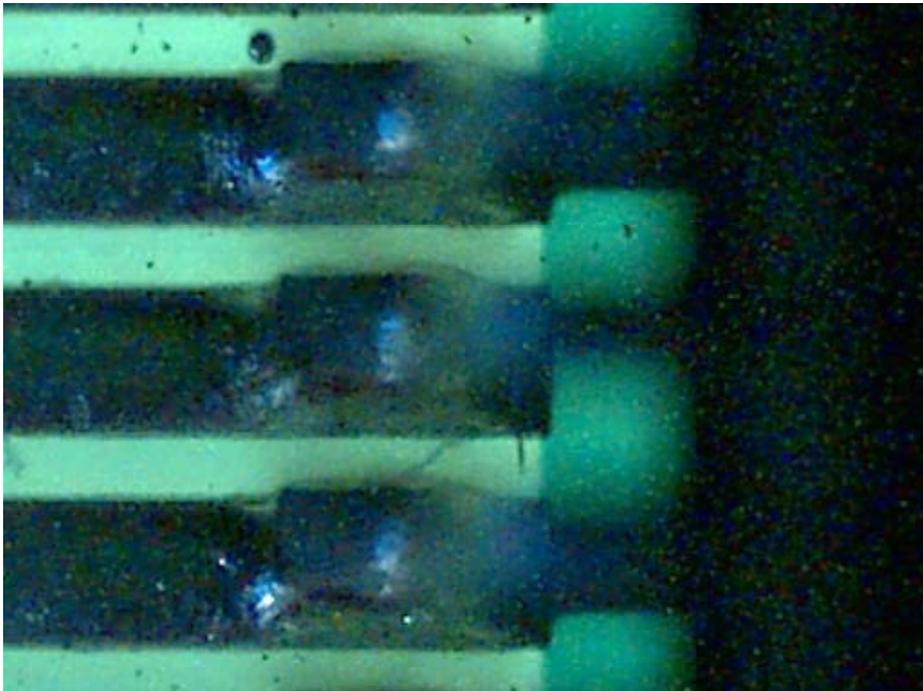
Pattern QFP160 (fiber backlighting) – Board 1

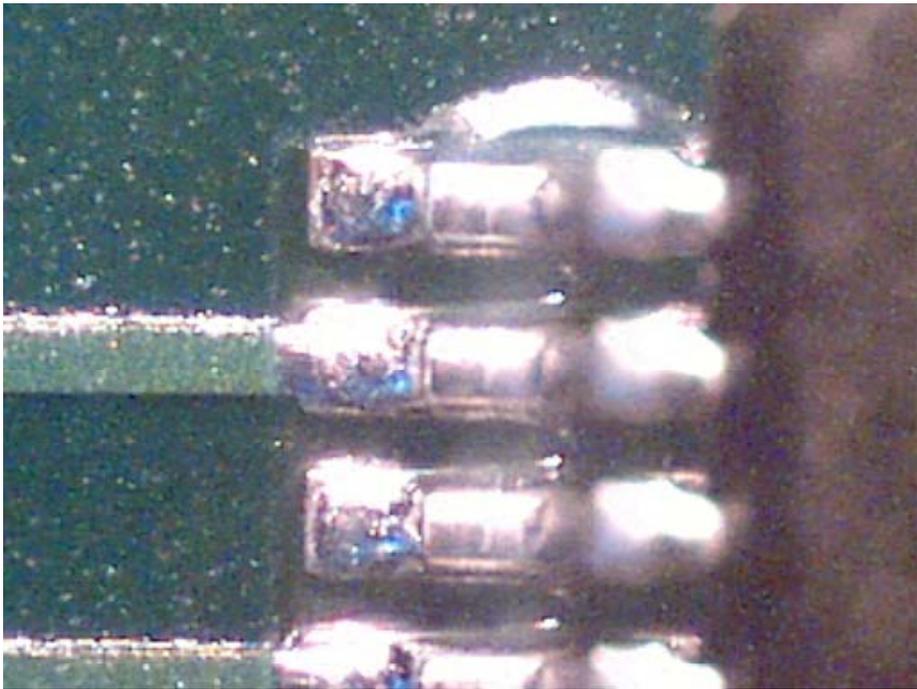
Pattern QFP80 (flux residue) – Board 1

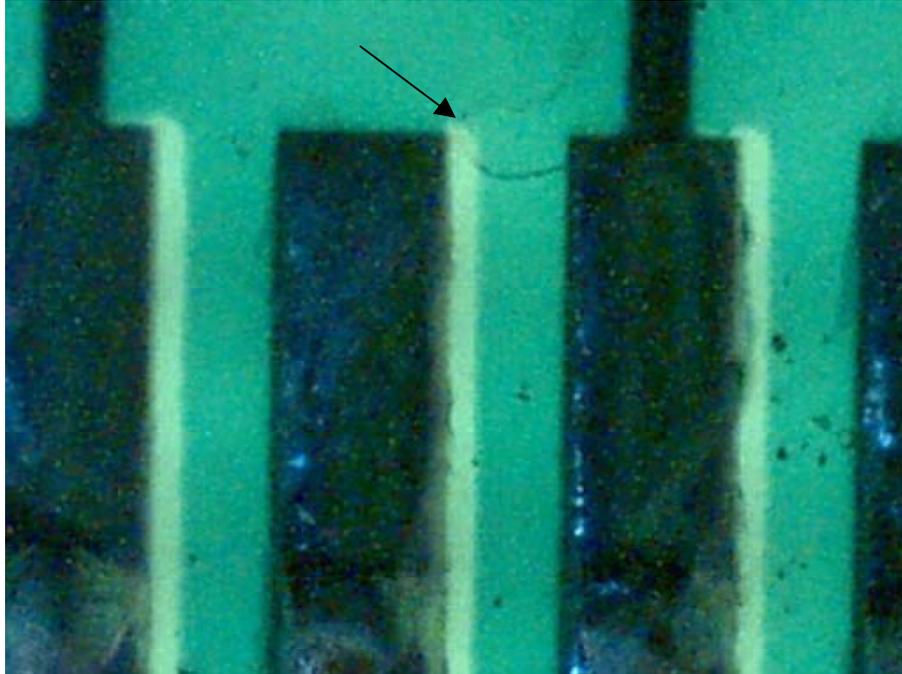
To contrast, the SMT connector sites were also processed with the same solder paste, but showed poor SIR levels for the entire test for all boards. In addition to noted flux residues, a few boards had fibers that spanned opposing conductors. Some fibers, depending on their composition, can lead to lower SIR levels, but we are suspicious that the boards were not adequately clean in that location. The control board had readings below the 9.0 LogOhm limit for several hours, which eventually recovered and continued to improve throughout the remainder of the test. This further suggests that there may have been residue left from the fabrication processes.

Pattern SMT Connector (fiber backlighting) – Board 1

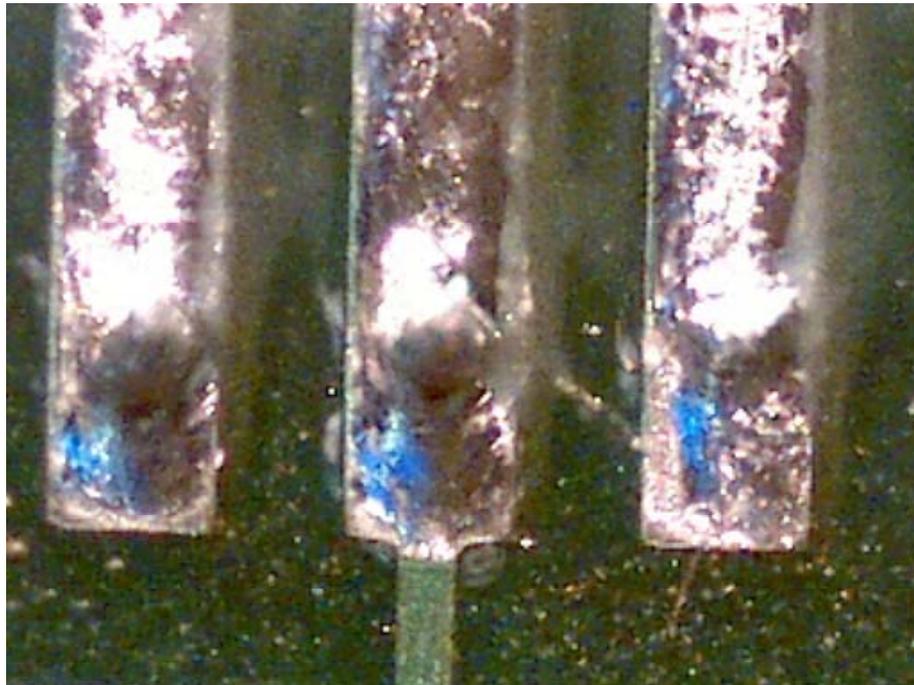
Pattern SMT Connector (fiber and flux residue) – Board 1

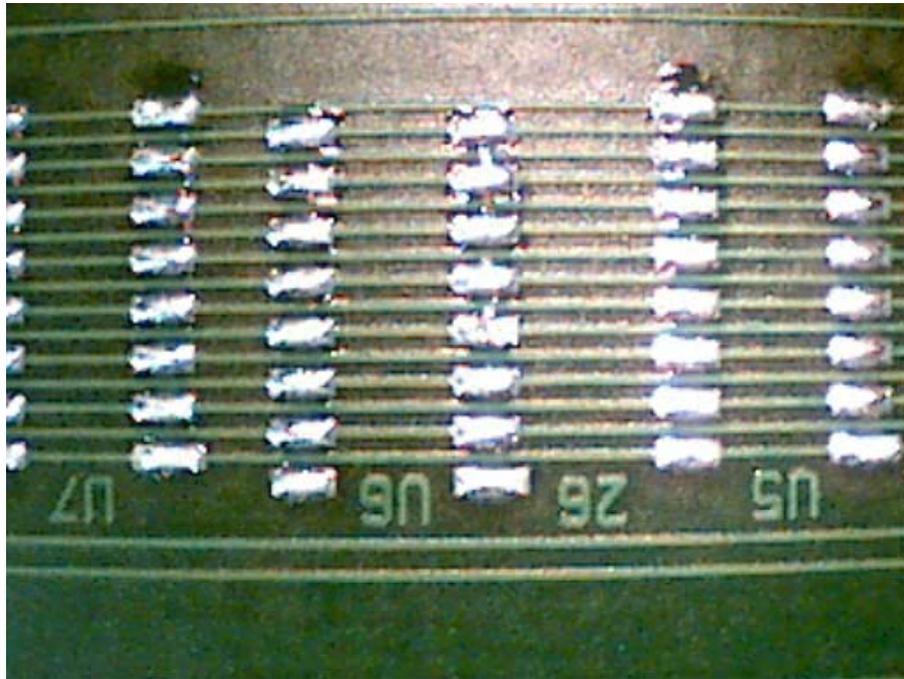
The SOIC locations also showed good SIR levels despite heavy flux residues noted for all boards. The BGA location showed good overall SIR performance for all

Pattern SOIC (flux residue) – Board 1

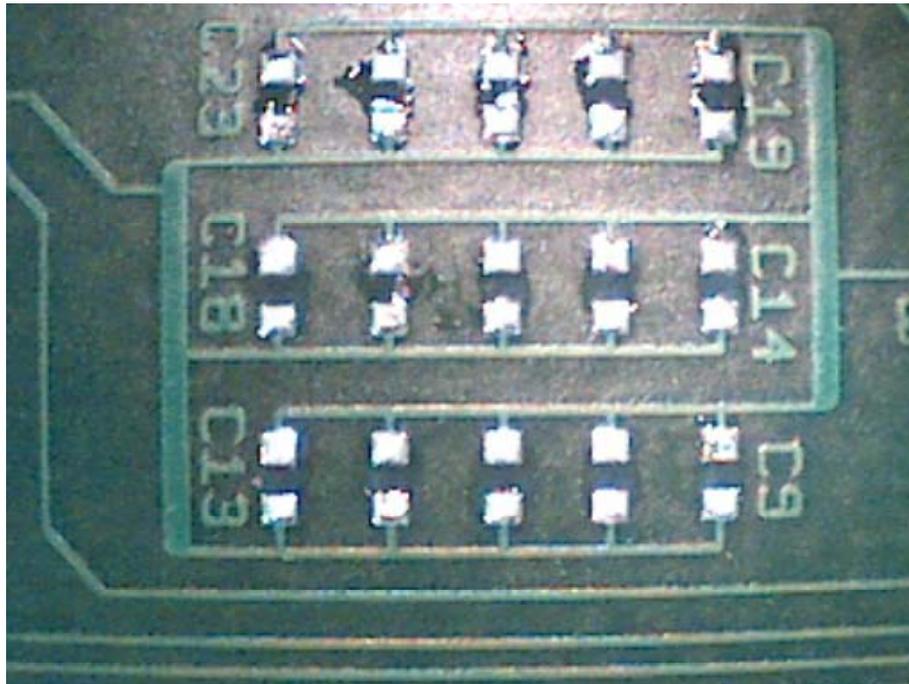
All of the surface mount capacitor locations showed good SIR performance despite the presence of heavy flux residue. The 0603 pattern on board 2 had one low reading at 116 hours, which recovered by the following reading. It continued to perform well for the remainder of the test.

Pattern 0603 (flux residue) – Board 1

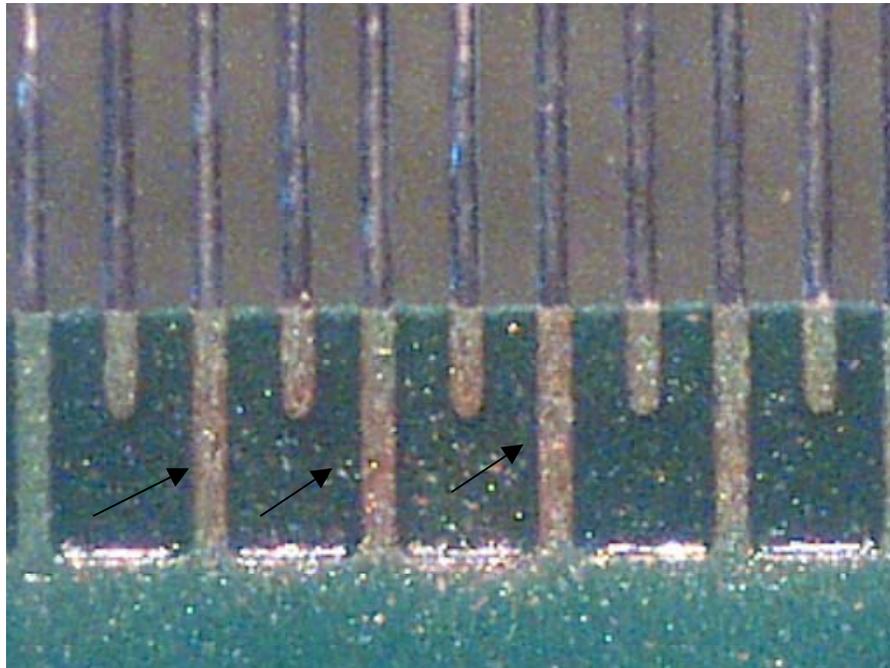
Pattern QFP 80 Comb (solder mask discoloration) – Board 2

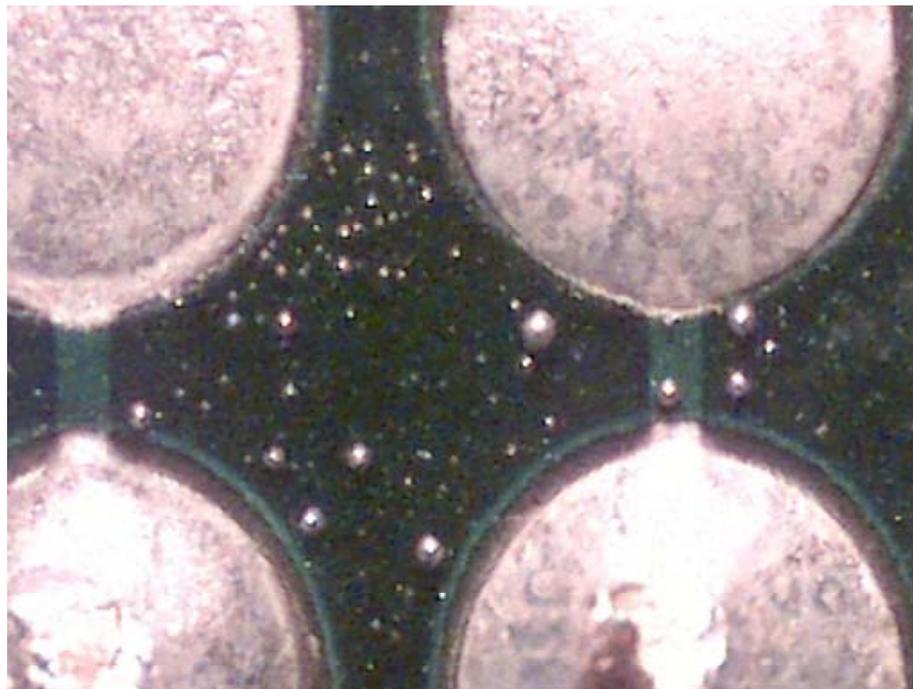
Other items that were noted were solder balls. Solder balls may be an indicator of several items from improper stencil size to old paste to incorrect reflow conditions. Further, we noted that the SMT connector location was easily damaged during part removal. We observed that the pads lifted very easily and in a few cases the traces also lifted from the board. We have not typically observed these types of issues when we have evaluated this board in the past. Lastly, we noted some discoloration of the solder mask on the bottom side of the control card. In addition, a few boards showed some discoloration of the solder mask over some of the traces.

Pattern J1 (solder balls) – Board 2

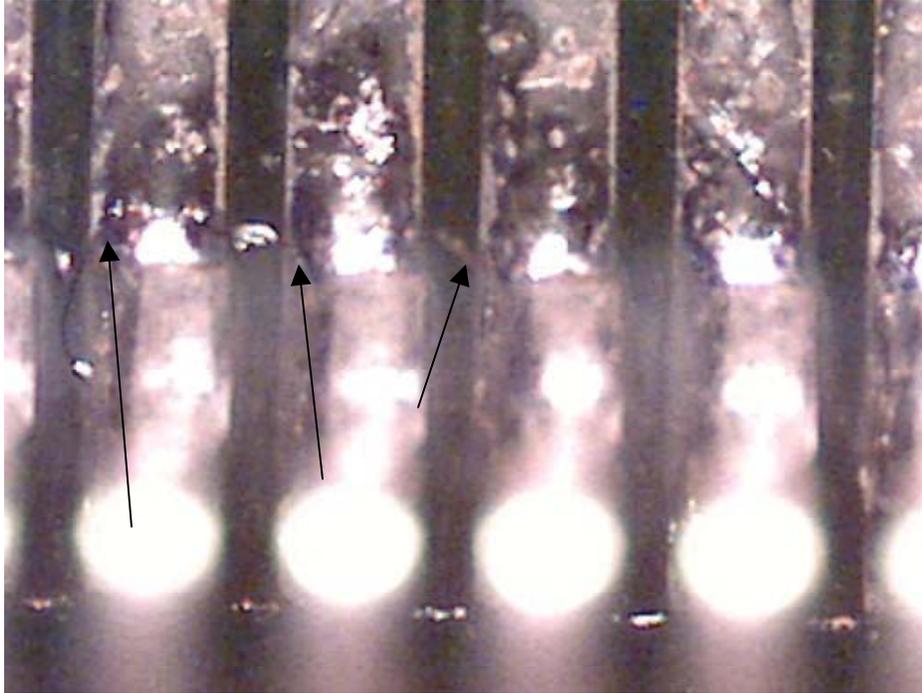
Pattern QFP160 (fiber) – Board 2

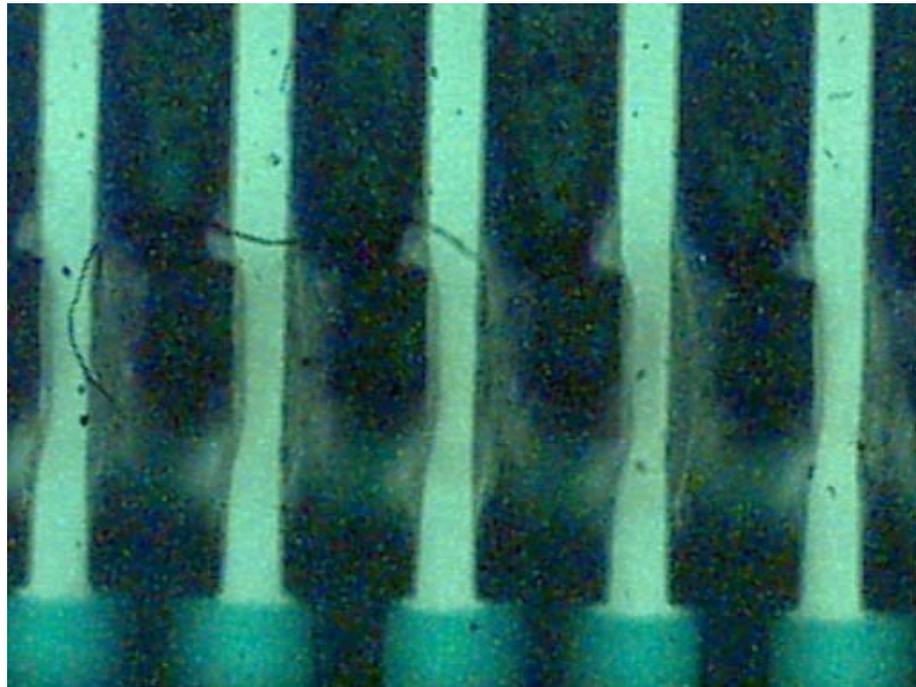
Pattern QFP160 (fiber backlighting) – Board 2

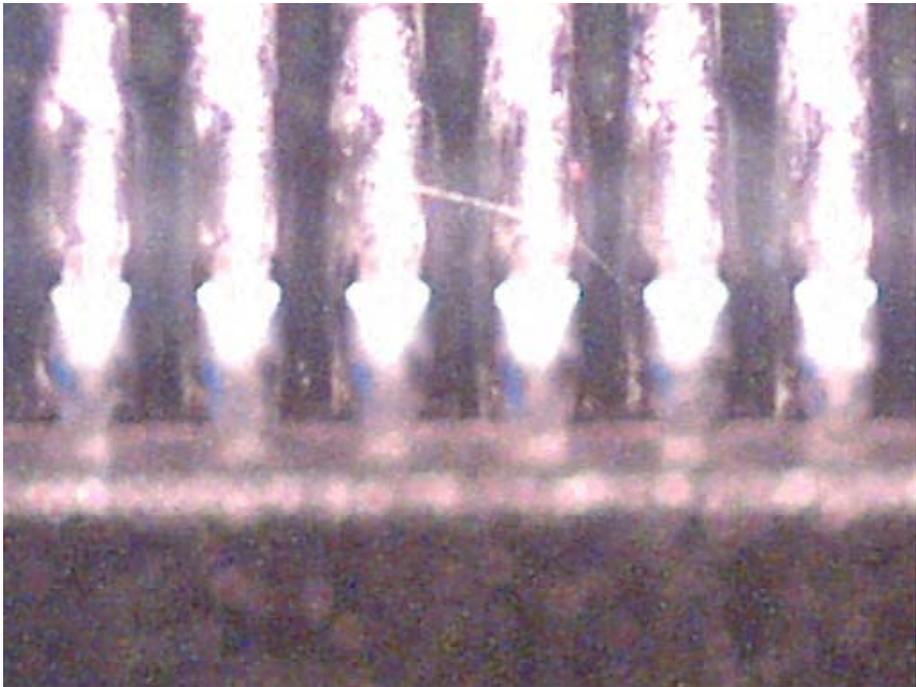
Pattern QFP80 (fiber) – Board 2

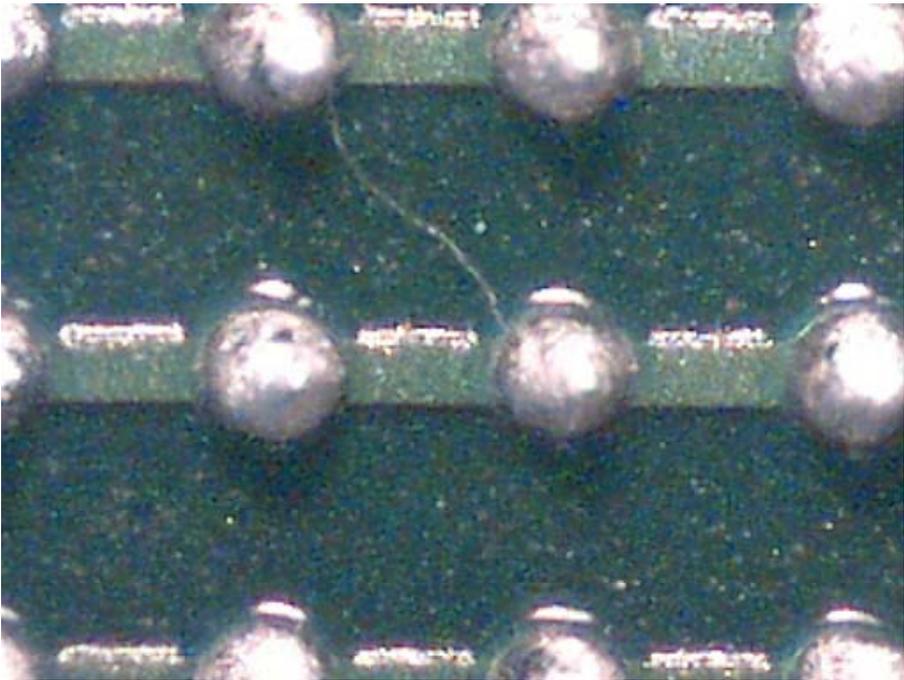
boards. The BGA site on board 4 was a little unstable compared to the other samples during the early part of the test. It recovered to above the limit by 24-hours and continued to improve for several hours before stabilizing at a very good level.

Pattern BGA (fiber and flux residue) – Board 3

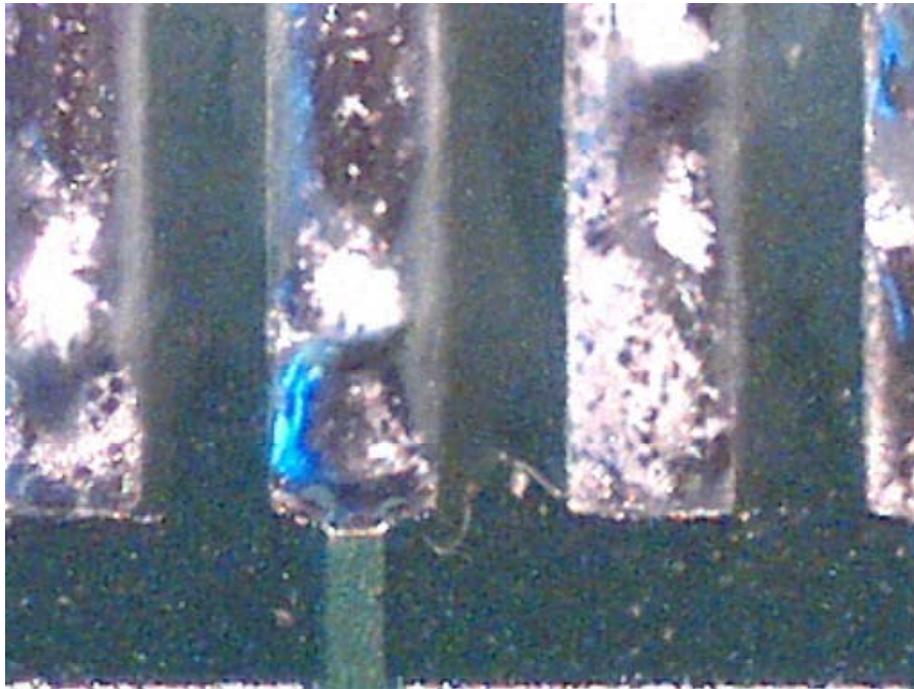
Pattern SMT Connector (fiber and flux residue) – Board 3

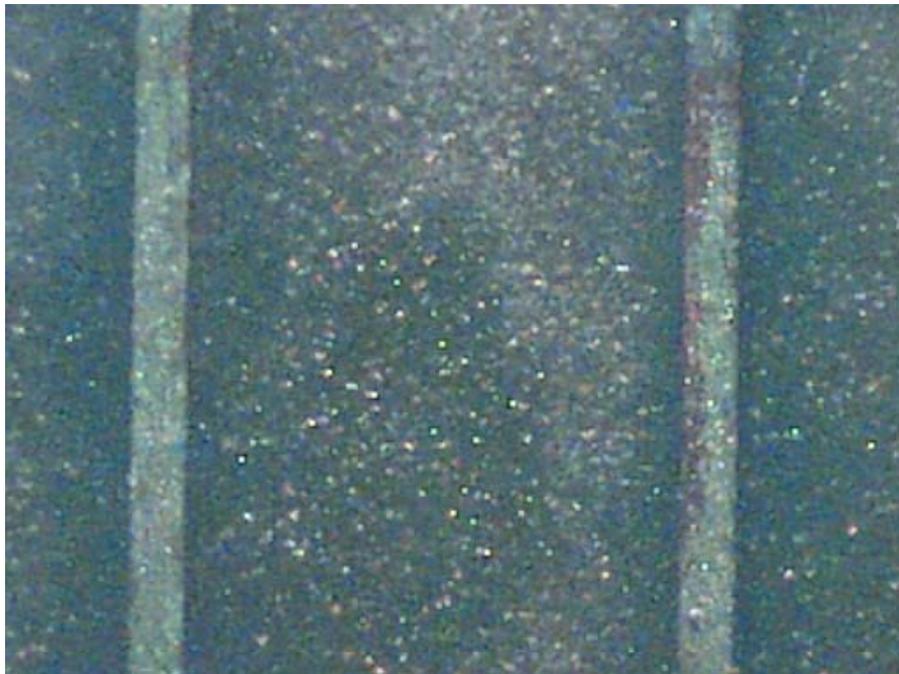
Pattern 0805B (solder mask discoloration over trace) – Board 4

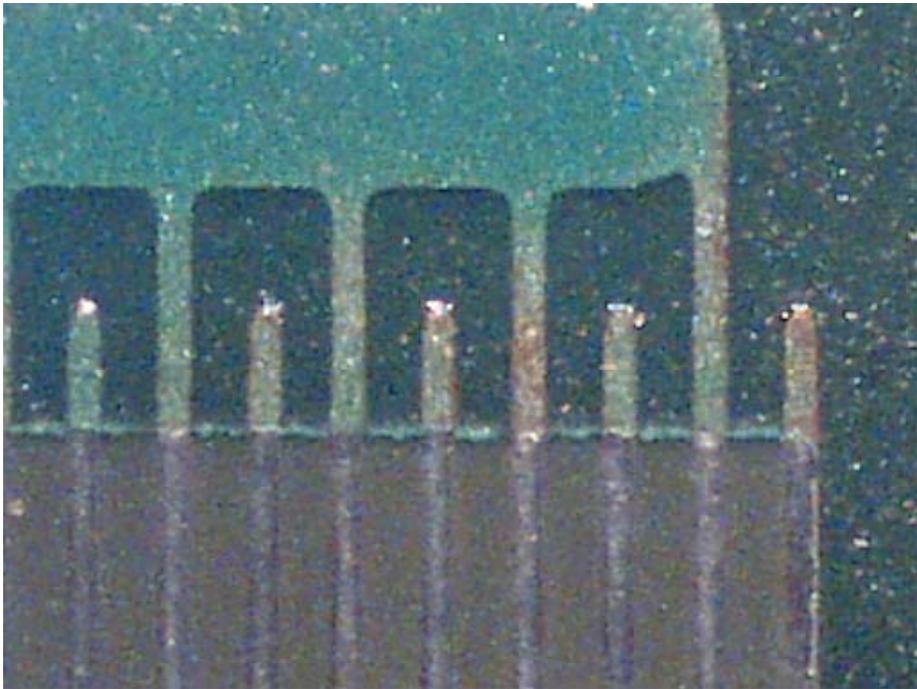
Pattern QFP80 Comb (solder mask discoloration) – Board 4
