## Surface Insulation Resistance (SIR) Analysis of IPC-B-52 Boards

Purchase Order #: 11111  
PAL Report Number: 2000-003

**Custom Solutions Inc**  
111 S. Client Blvd.  
Someplace, IN 46900

Date: March 02, 2010

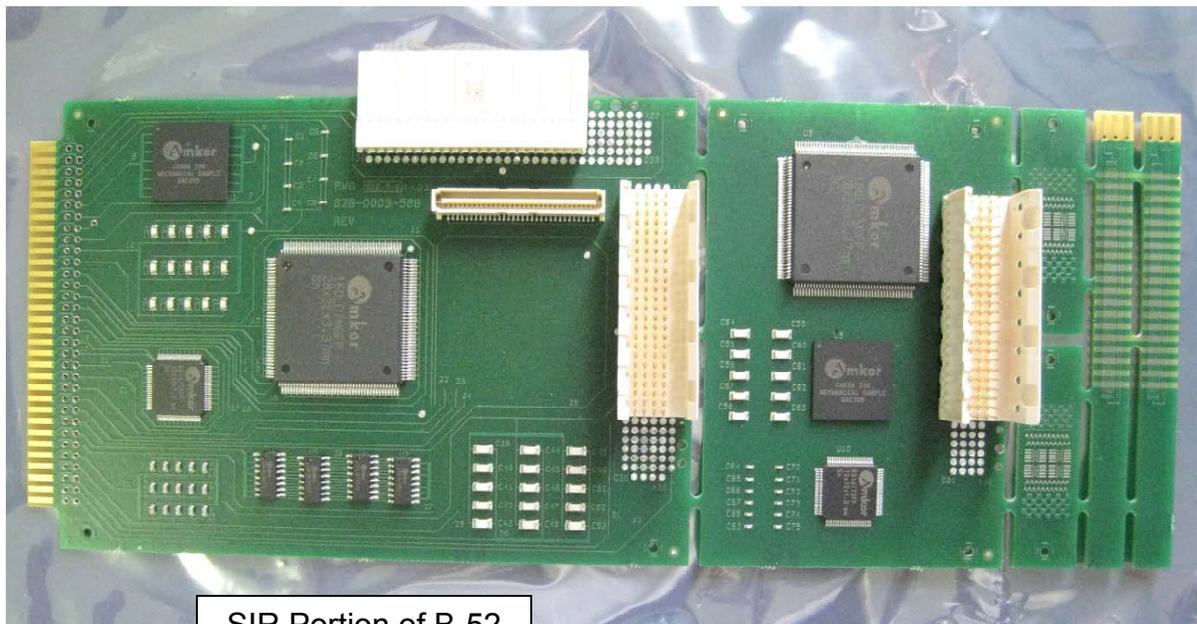
## **Sample Photograph**

The boards appeared to be made of standard FR-4 epoxy-glass laminate and covered with a green-pigmented solder mask. The surface finish appeared to be a hot air solder leveled (HASL) finish. One board was provided as a “control”. The remaining samples were processed using lead-free solder materials. No other information was provided with respect to the soldering materials or the processing conditions.
